DIAGNOSTIC STUDY OF BALL LAKE

Diagnostic Study
of Ball Lake

January 2003

Prepared by:
F. X. Browne, Inc.
Saranac Lake NY • Lansdale PA

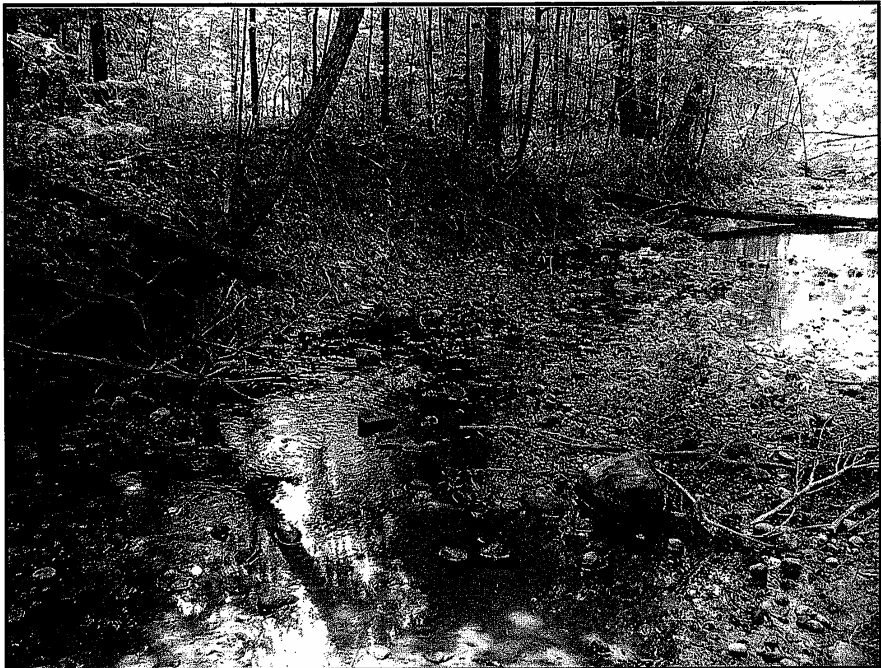
Figure 7.1 Example of Stream Bank Erosion in Ball Lake Watershed at Site B

The locations of specific problem areas that were identified as part of the field investigations are shown in Figure 7.2. With the exception of site M2, an animal feedlot, all problem areas identified in the figure are streambank erosion problems. Streambank erosion problems should be stabilized using bioengineering or structural methods, and a buffer should be maintained around the feedlot. Typical examples of streambank erosion in the Ball Lake watershed are shown in Figure 7.1 and in Figures 7.3 and 7.4.

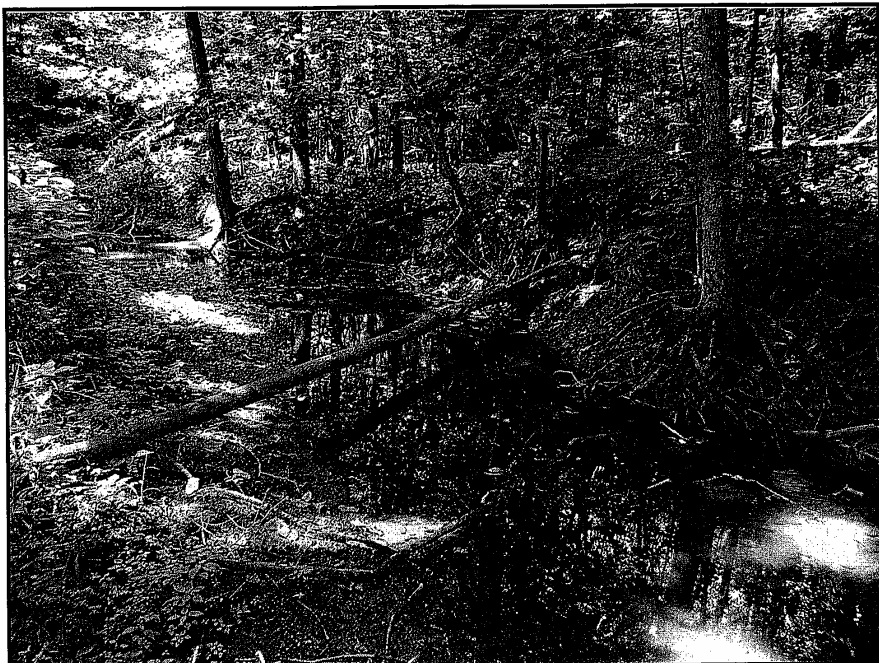
Figure 7.3 Example of Stream Bank Erosion in Ball Lake Watershed at Site E
